Structural Failures

A Case Study

Researched by Sam A. Rihani, PE, F.ASCE, SECB – September 2005

Hartford Coliseum

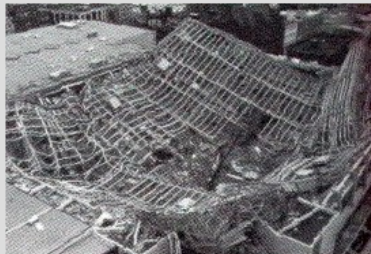
This roof was noted for being one of the first large-span roofs made possible by computer design and analysis, and was modeled as a space truss using a trusted program. The roof of this three-year-old structure collapsed at 4:15 AM on January 18, 1978 during a freezing rainstorm after a period of snow. Fortunately, there were no injuries sustained as a result of the collapse. The night before, there were over 5,000 people in the coliseum attending a basketball game. Following several investigations of the collapse, it was determined that this was an instance primarily of inadequate structural design.

A triangular lattice steel space grid, supported on four reinforced concrete pylons giving spans of 270 feet and 210 feet, was used to support the roof. Smith and Epstein concluded that the interaction of top chord compression members and their bracing played an important role in the redistribution of load and the eventual collapse. They noted that certain compression members were braced against buckling only in one plane. As loads increased, these members buckled out of plane and redistributed the loads to other members. Over a period of time, more chords buckled and fewer and fewer members carried the load. This situation worsened until the remaining members were unable to withstand the added stress due to the loads present that night, and the final, sudden collapse took place.
